SUBJECT: Aqua Plus® Water Heater Maintenance – Anode Inspection Necessary

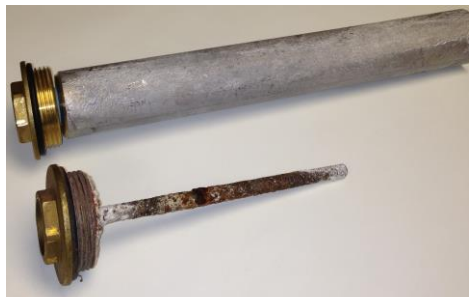
New Sacrificial Anode

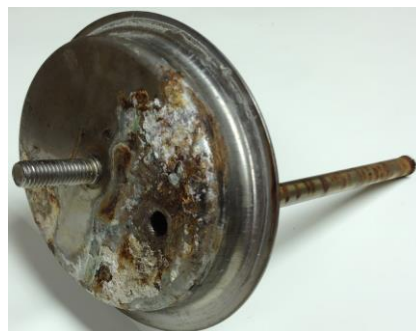
Depleted Sacrificial Anode

1. Note where the leak is coming from, if it is from the thermostat drywell, replace the inspection plate (which the drywell is part of) – no need to replace the entire water heater.
2. Check the anode rod and replace if necessary. More than likely, if there is a leak from the thermostat dry well, the anode is completely depleted.
3. Check the condition of the thermostat sensing bulb, if it has been compromised due to the leak, replace the thermostat.

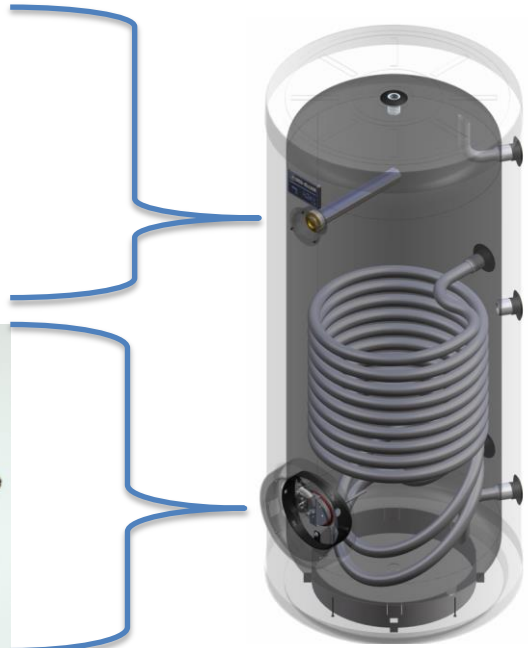
If an anode rod is completely depleted and remains unchecked, a potential corrosion point might begin on the thermostat drywell (which is located on the inspection plate), and subsequently could result in a leak – this is not a warranty covered issue.

Leaking Corroded Drywell / Inspection Plate Due to Depleted Anode
