Marketing Bulletin

BULLETIN NO: MB-0820 DATE: December 8, 2008

SUBJECT: Updated U-Control Software on Ultra Gas Series 3 Boilers

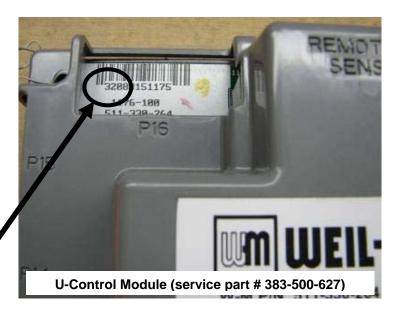
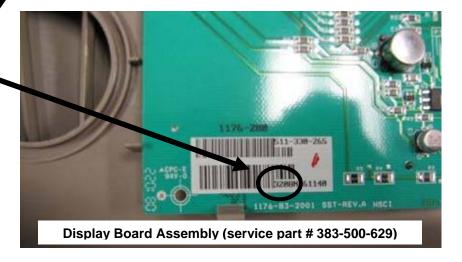
3. DATE CODE

Updated software date codefirst four digits 4008 or higher

Original software date codefirst four digits 3908 or lower

Datecode: WWYY

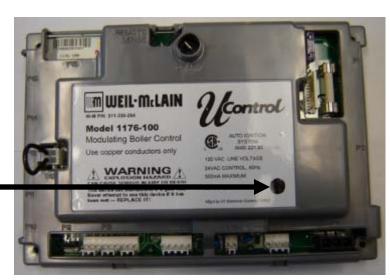
U-Control Module (service part # 383-500-627)

Reprogrammed control has a black dot on lower right hand corner of label
