### **SUBJECT: Aqua Plus Recirculation Plug Removal Issue**

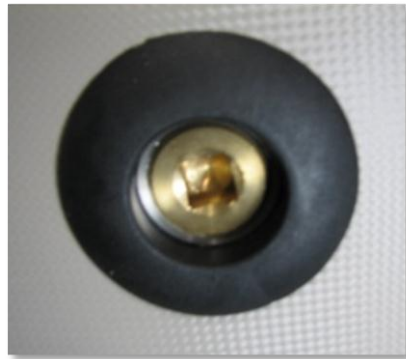
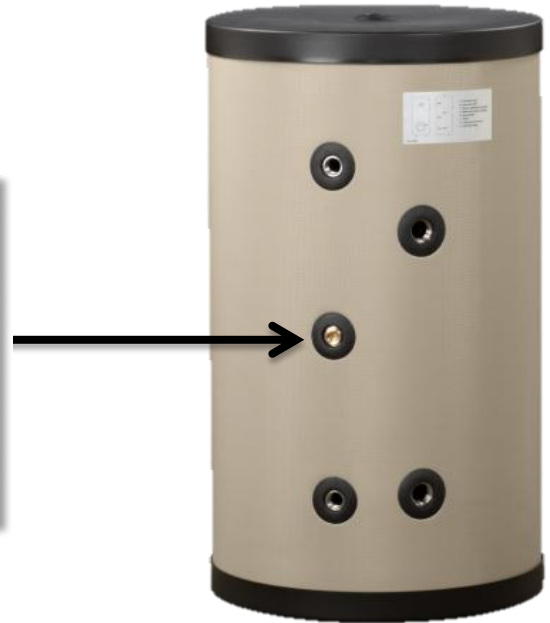
**Recirculation Plug  
Water Inlet Tapping**

There have been some reported occurrences in the field where the recirculation plug in the Aqua Plus indirect-fired water heater has been difficult to remove (see pictures below). We have reduced the torque setting in mid-November, 2011- beginning with Aqua Plus serial number EO4916110001.

To remove the recirculation plug, use a 1/2" drive breaker bar. If more leverage is necessary, use a pipe extension. If the fitting will not break loose, or if the head of the recirculation plug strips out, the tank may be replaced under warranty.
