### **Case Study**

# Mendota Apartments

#### **Boiler Replacement Needs:**

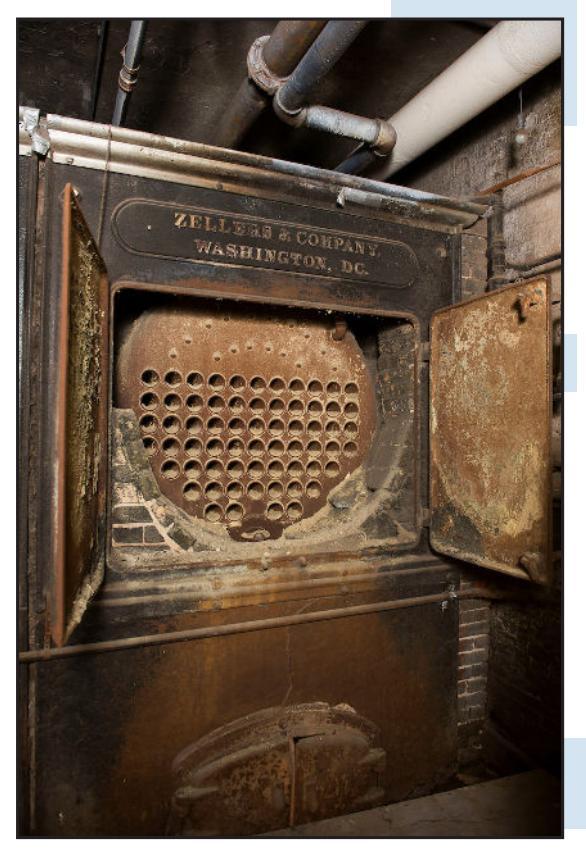
The existing steam boiler, in place for over 40 years

Dan Foley, president and owner of Foley Mechanical, Inc., based in Lorton, Va., was selected to help remedy the heating woes. "When we started working with Mendota, a 40-year old steam boiler provided heat," said Foley. "Upon inspection, we noticed the boiler fired all day long and never shut off."

Foley also noted that the main venting system was not appropriate for the two 6-inch steel mains that circled the basement of the facility. The boiler would flood on a regular basis, and the condensate would lag as it percolated through the clogged wet returns.

"When the condensate would finally return, the boiler would flood, which required a service call," said Foley. "Water continuously drained from the boiler as fresh water was added, causing the boiler to disintegrate from the inside out." Foley and Wood decided first to make incremental improvements to the aging boiler.

Enhancements included, but were not limited to, replacing multiple ribbon burners, replacing the boiler relief valve and safety controls and rebuilding the main venting system. Despite improvements, the comfort of

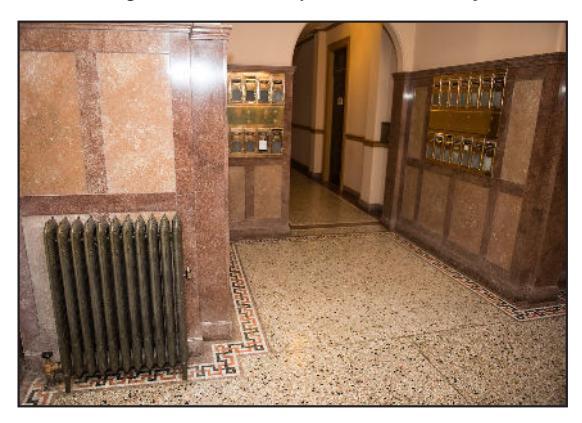
A view of the Mendota's lobby with column-style cast iron radiators.

Another historic feature is the Mendota's original heating system – which consisted of a coal-fired boiler that's still in place but has long been disconnected. The Mendota is heated by a one-pipe steam system connected to column-style cast iron radiators.

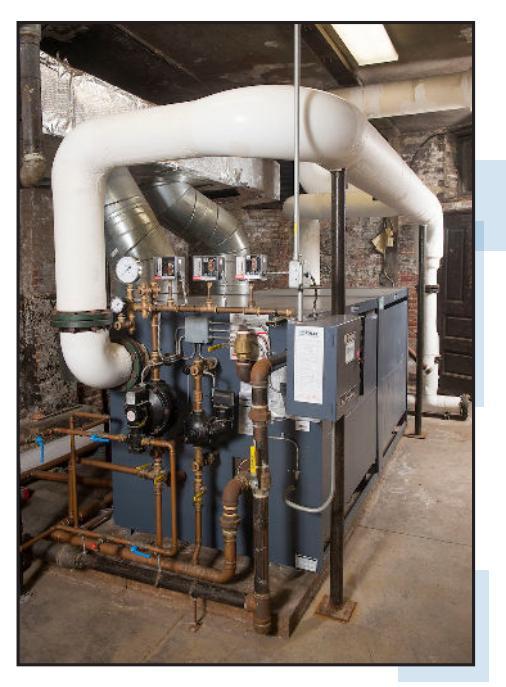
The Weil-McLain LGB-20 steam boiler in the Mendota boiler room

Foley recommended installation of a Weil-McLain LGB-20 atmospheric draft steam boiler at 2.5 million BTUs. At up to 84% combustion efficiency, the LGB line is one of the more efficient commercial cast iron atmospheric Weil-McLain gas boilers. Its compact design allows for more

piping and venting headroom and the unit's short draw rods permit faster, easier assembly of boiler sections. The boiler was sized to the connected radiation using a 1.5 pick-up factor. The header was repiped to manufacturer specifications.

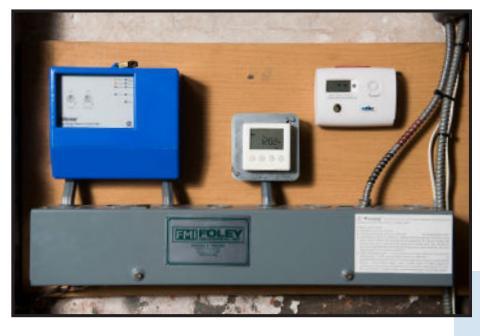
Additional controls in the Mendota boiler room

"We actually installed a few dozen additional radiators that had been removed with the previous system because it had been run at such a high level that the building was overheating in some areas," said Wood. The operational parameters of the boiler don't have to be changed throughout the year. "The controls are such that we don't make adjustments at all," said Wood. "The system learns and fine-tunes settings as needed."

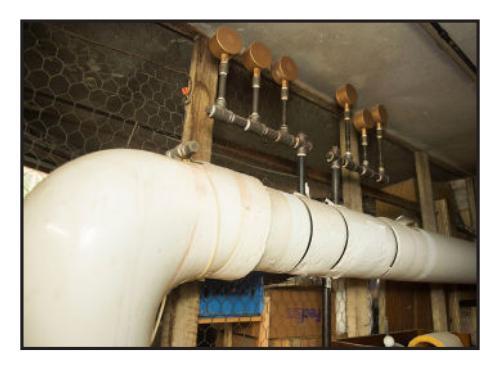
Piping and gauges in the Mendota boiler room

"Before we removed the old boiler, we conducted a system overhaul to optimize the distribution piping, vents and the radiators in every room," said Wood. "We then installed new main line steam vents, both at the beginning and the end of the line, checked all the mud legs and replaced the near boiler piping because it had been clogged.
